## STRUCTURAL CONDITION ASSESSMENT AND REHABILITATION PROPOSALS - CASE STUDY PARTIZAN SPORTS COMPLEX IN MOSTAR

Azra Mahinić Vrce<sup>1</sup>, Merima Salčin<sup>2</sup>, Marko Čećez<sup>3</sup>,  
Merima Šahinagić-Isović<sup>4</sup>

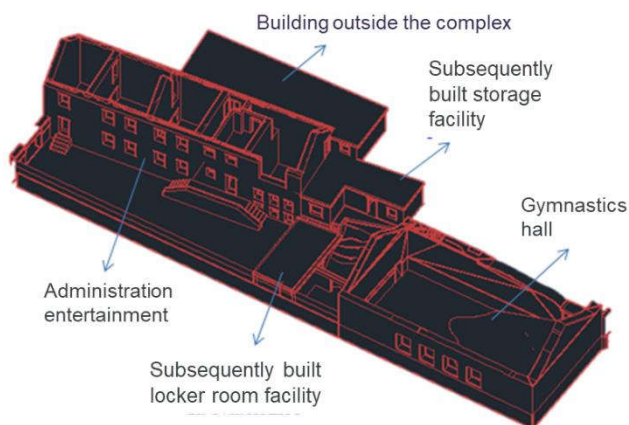
Figure 2. The current state of the Partizan complex

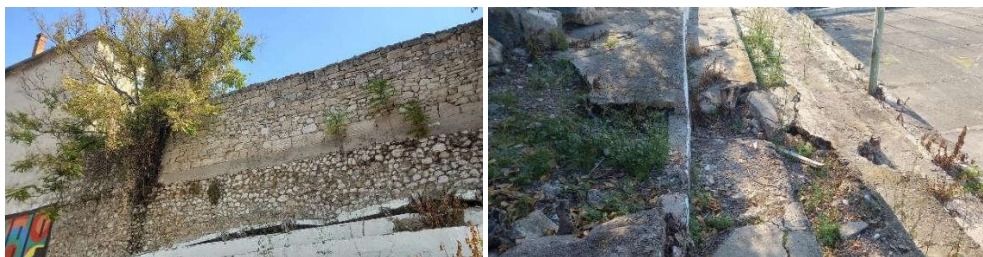
Upon entering the sports field area, it is evident that there are numerous damages caused by various factors. The stands have various physical damages that occurred from grenade impacts during the war, while the remaining significant damages are due to large tree roots that have destroyed much of the stands. There are mechanical damages as well as significant material loss. The entire wall shows signs of joints washout, the crown (top layers of stone) and the wall cap are missing. The most notable damage on the wall is the damage to the buttress and the damage at the window location—both areas have been identified with dense vegetation, such as trees (Fig.3). The stands consist of concrete slabs 15-20 cm thick, laid on a foundation of compacted earth (Fig.3). An additional issue regularly encountered is the runoff rainwater that flows from the surrounding area, accumulating on the field and causing problems for adjacent buildings. The field is made of concrete slabs, which have been better preserved than the stands, but there are still damages to the surface layers and cracks.

*Figure 3. Damage to the wall and stands of building A*

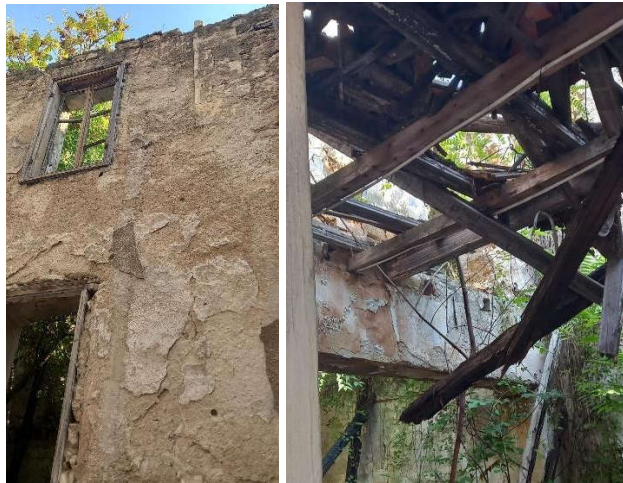
The administration building has significant damage from a fire to which the building was exposed. The eastern and northern external facades do not show major structural failures, except for localized detachment of stone blocks (Fig. 4). The walls are stable and in relatively good condition. The building also shows damage from vegetation that has covered its interior, so the true condition of the building could only be assessed once the rubble and vegetation are removed. However, localized damage around the windows and wall cornices is present throughout the entire wall. Around some windows, the detachment of stone blocks is visible (Fig.4). The detachment of blocks is also visible on the cornices beneath the roof. The existing mortar is in very poor condition, with large sections of the building either missing or damaged, and in some places, it is visibly detached from the wall.

*Figure 4. Damage to the walls and interior of building B*

The roof of this building was destroyed during the fire and because of the collapse of the wooden structure that it rested on, the material at the support points was crushed. Remnants of the wooden structure are inside the building and the effects of the fire are visible on them. The floor structure also suffered from the effects of the fire and was completely damaged.

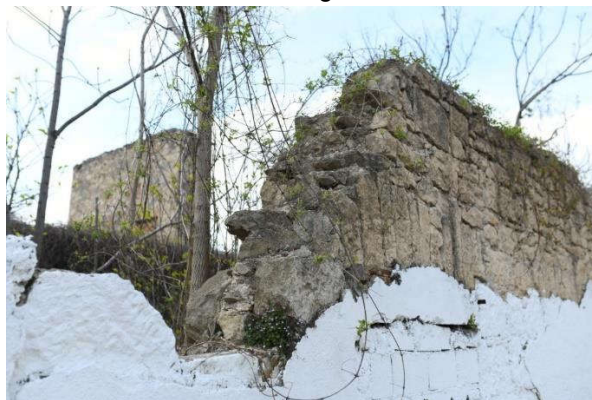
The stone walls are in good condition; however, further testing will determine their actual state in terms of mechanical properties. A large part of the building is missing the mortar and sections of the wall (Fig.5). As for the roof structure and the floor structure, they are completely destroyed. The interior of the building is filled with rubble and vegetation.

*Figure 5. Damage of the building C*
