Review paper

THERMAL BRIDGES AS INDICATORS OF INSTALLATION DEFICIENCIES IN ETICS FACADES

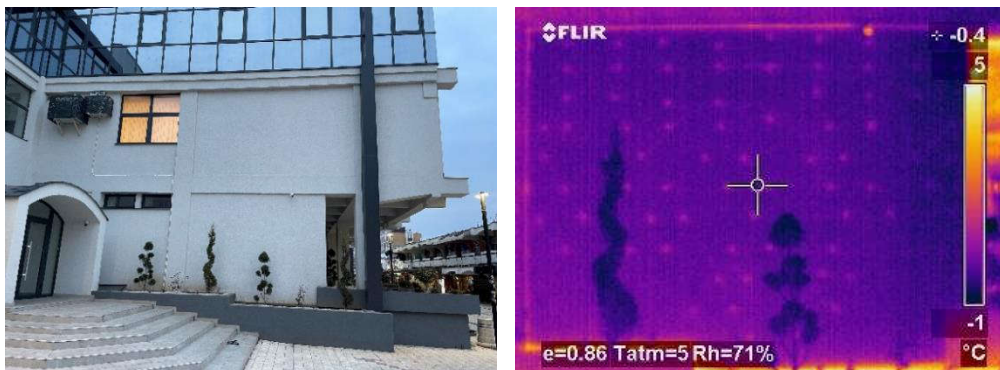
Figure 3. Part of the South-East Façade and Its Thermographic Image

Additional analysis of the available photo-documentation and technical reports indicated several irregularities that led to the partial collapse of the facade of the House of Culture in Pirot carried out in the ETICS system. Among the key causes, inadequate preparation of the substrate was singled out, whereby basic mechanical operations, such as rough treatment ("scratching" or "etching"), necessary to ensure adequate adhesion, were not carried out. Of particular concern is that the thermal insulation system was applied directly over the wall and painted with an acrylic mural without prior treatment, which seriously impaired the stability and adhesion of the layers of the system.

The photo-documentation additionally indicated the improper application of the glue on the thermal insulation boards made of mineral wool, which resulted in uneven adhesion and weakening of the adhesive properties of the facade system (Figure 3). Inadequate installation of panels in the corner area of the building was observed without applying the so-called "binding" (alternate overlapping), which resulted in the structural weakening of the facade covering in critical places (Figure 4). Improper processing of edges and corners, as well as incorrectly placed reinforcing mesh, additionally contributed to the reduction of mechanical resistance and overall stability of the system.

The identified irregularities point to systemic deficiencies in the preparation of the substrate, the installation of thermal insulation boards, and the general quality of the work performed, which resulted in the partial collapse of the facade. Based on the findings, it is recommended that the critical parts of the facade be reconstructed with strict adherence to project documentation.

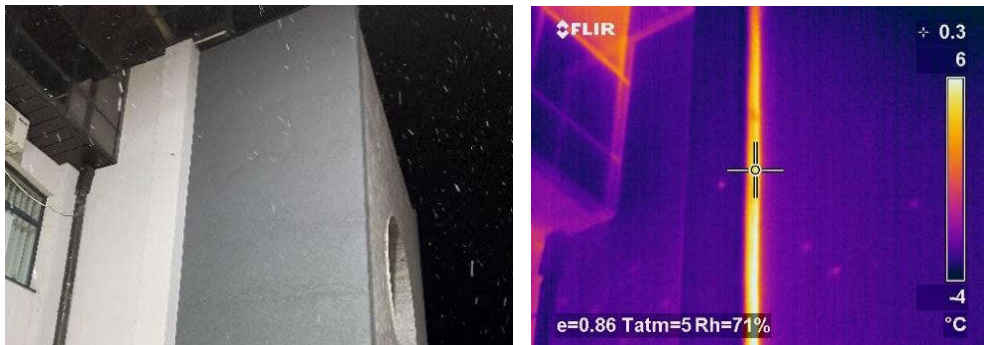
Figure 4. Part of the North-West Façade and Its Thermographic Image

Thermal bridges are most often identified at the points of joints and penetrations through the facade system, where there is a significant increase in heat losses and an increase in the building's heating needs. Thermographic analysis indicated the presence of pronounced thermal anomalies in the area of the fastening points and along the perimeter of the window openings, which means inadequate covering with thermal insulation and omissions in execution. The observed deficiencies contribute to increased heat loss and the risk of condensation, especially in the winter [19].

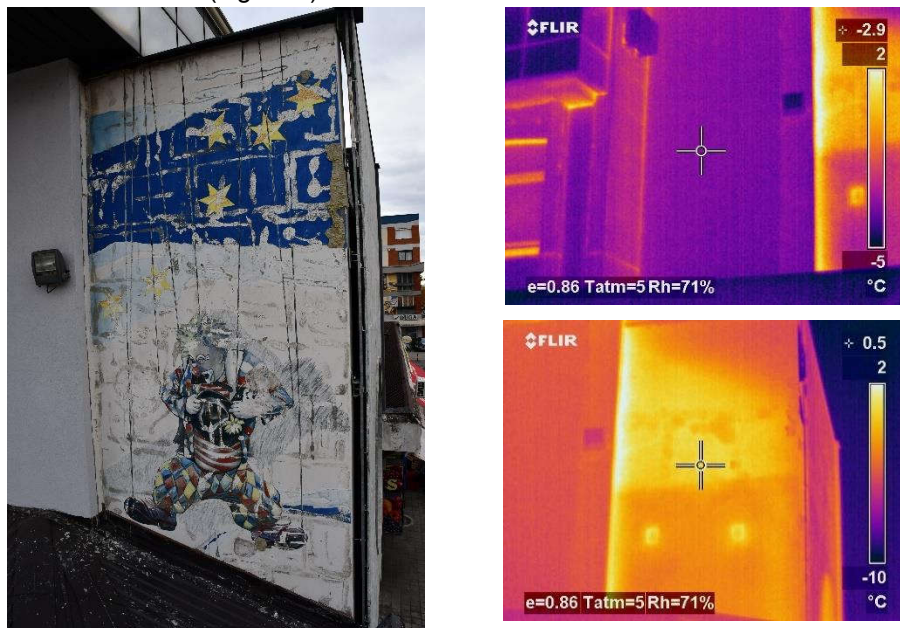
Figure 5. Part of the North-West Façade and Its Thermographic Image

One of the most serious omissions is reflected in the complete absence of doweling, which is the essential structural element for the mechanical fastening of thermal insulation boards. Thermographic images clearly showed the lack of dowels on specific facade segments, jeopardizing the system's resistance to external influences and long-term stability. According to the basic technical standards, installing dowels is a mandatory measure to achieve durability and reliability of the ETICS system, and their absence is considered a gross failure in the execution of works (Figure 5).
