## **NON-DESTRUCTIVE INVESTIGATION ON HERITAGE BUILDINGS - CASE STUDY ON ST. NIKITA CHURCH**

*This paper presents the investigation campaign carried out to one heritage building – the Byzantine church of St. Nikita near Skopje, North Macedonia. The methodology involved archival research, review of the monument's documentation and in-situ investigation using several Non-Destructive Techniques (NDTs): visual inspections, microscopy, infrared thermography, 3D laser scanning and ambient vibration tests. This integrated methodology provided information for both, historical context and current condition of the building. NDTs proved to be a useful diagnostic tool for condition assessment of the monument without affecting its authenticity, which is especially important for this type of buildings.*

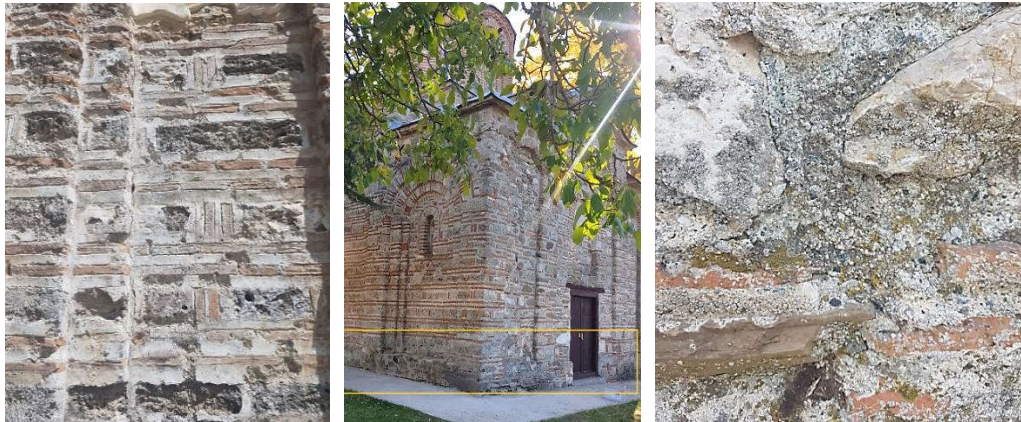
During facade inspections, it was observed that the materials are generally well-preserved, showing no significant signs of degradation. However, certain irregularities were noted (fig. 4) such as: pronounced porosity of the limestone and carbonation of the lime

plaster; presence of capillary moisture in the lower zones of the northern and western walls; presence of bio-organisms (mostly lichens) in the lower and middle zones of all facades.

*Figure 4. Porous limestone (left), presence of capillary moisture (center), presence of bio-organisms (right), [3]*

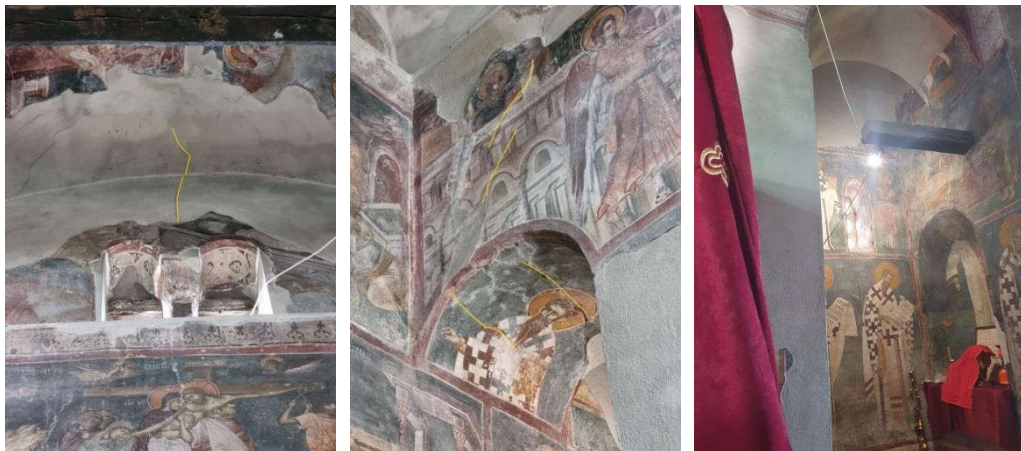
The interior of the church is entirely plastered and painted with frescoes, which prevents any direct investigation of the condition of the underlying construction materials. Fine cracks are visible in the upper areas at several locations (fig. 5) and the most prominent is an old crack on the western wall, above the door. More substantial damage was noted on one of the wooden tie beams - the beam linking the altar area to the north-east pillar is disconnected (fig. 5).

*Figure 5. Presence of damages in the upper zones of the church, fine cracks (left and middle), disruption of wooden tie (right), [3]*

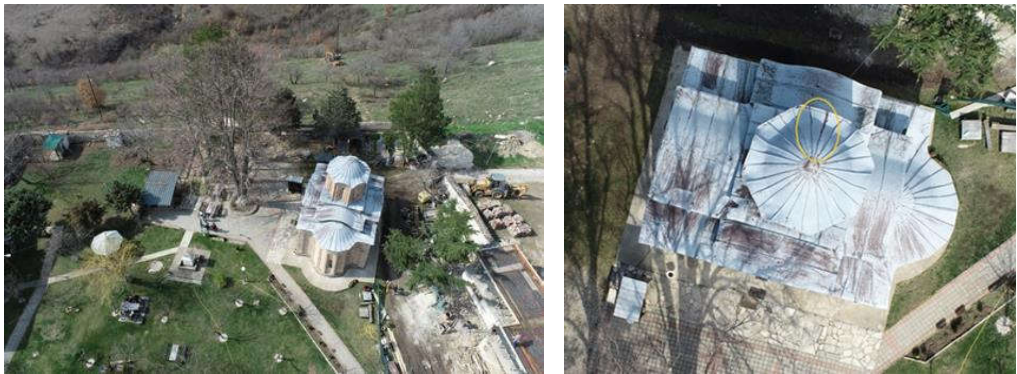
The use of a drone provided access to hard-to-reach areas that posed challenge during visual inspections. High-resolution aerial photographs (fig. 6) provided a detailed perspective of the church's positioning within its immediate surroundings and enabled inspection of the roof covering. It was noted that the roofing material is overall in good and well-maintained condition, except of the dome area, where some material cracking was observed (fig. 6 right), likely resulting from improper joint installation.

Figure 6. Aerial perspective of St. Nikita church, [3]

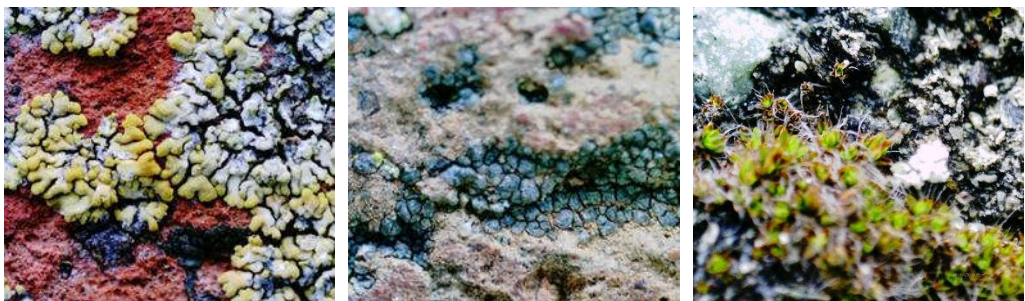
Figure 7. Different types of lichens present on the facade surfaces (images from a digital microscope with 40x magnification), [3]

So far, the presence of lichens has not caused any significant damage on the facade materials (some micro cracks and color change of materials were observed). In fact, it requires long period of time for certain degradation processes to occur. Additionally, most of the lichens are tightly connected to the surface and their mechanical removal is practically impossible without damaging the underlying material.

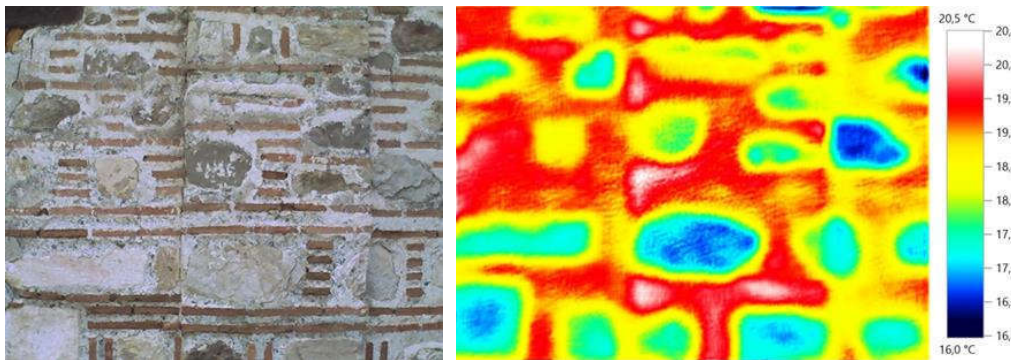
Figure 8 shows a segment of the masonry on the western facade of the building along with the corresponding thermal image. The thermal image displays temperature variations ranging from  $16^\circ\text{C}$  to  $20.5^\circ\text{C}$ , with the lowest temperatures observed in the stone and the highest in the bricks, due to the different thermal properties of the materials. Additionally, the surface temperatures of the stone pieces showing signs of degradation are lower compared to those with better surface conditions, which can be attributed to porosity or moisture retention. This temperature difference is approximately  $1^\circ\text{C}$ .

*Figure 8. A segment of the masonry of St. Nikita Church (left), corresponding thermal image (right), [3]*

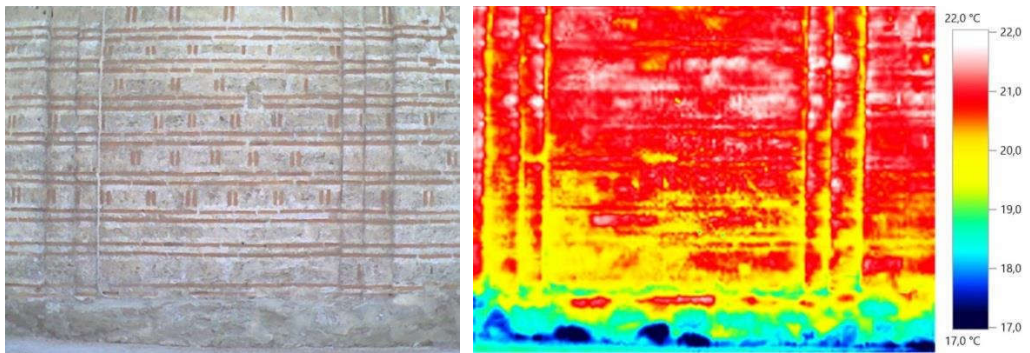
The thermal camera enabled more accurate detection of moisture distribution within the walls. Figure 9 shows part of the northern wall (exterior side), along with the corresponding thermal image. The thermal images display irregular patterns of thermal anomalies, characteristic for moisture areas. Changes in moisture content can be correlated with surface temperature variations, and the moisture-affected areas show lower temperatures (indicated in blue color), compared to the rest of the facade's surface. It was concluded that the highest moisture levels are in the bottom of the walls, rising up to 60-80 cm.

Figure 9. A segment of the northern facade of St. Nikita Church and the corresponding thermal image, [3]

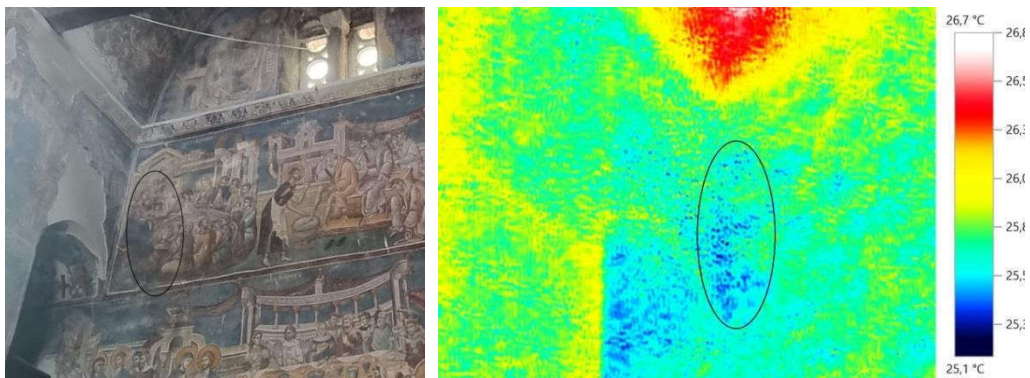
The original frescoes in the interior of the church date back to the 14<sup>th</sup> century. In a later period (15<sup>th</sup> and 19<sup>th</sup> centuries), some of the damaged frescoes were partially restored, and some were repainted on a new layer of plaster, in a manner similar to the originals, making it often difficult to distinguish. The frescoes, which belong to different periods or masters, vary in composition and characteristics and have different emissive values, which can be detected on thermal camera. Figure 10 shows one composition of the southern wall, where no visible surface changes are observed. However, the thermal image of this part reveals temperature variations, precisely an area with a lower temperature (indicated by a black circle), which could suggest that part of the composition belongs to a different period.

Figure 10. Fresco painting on the southern wall with corresponding thermal image, [3]

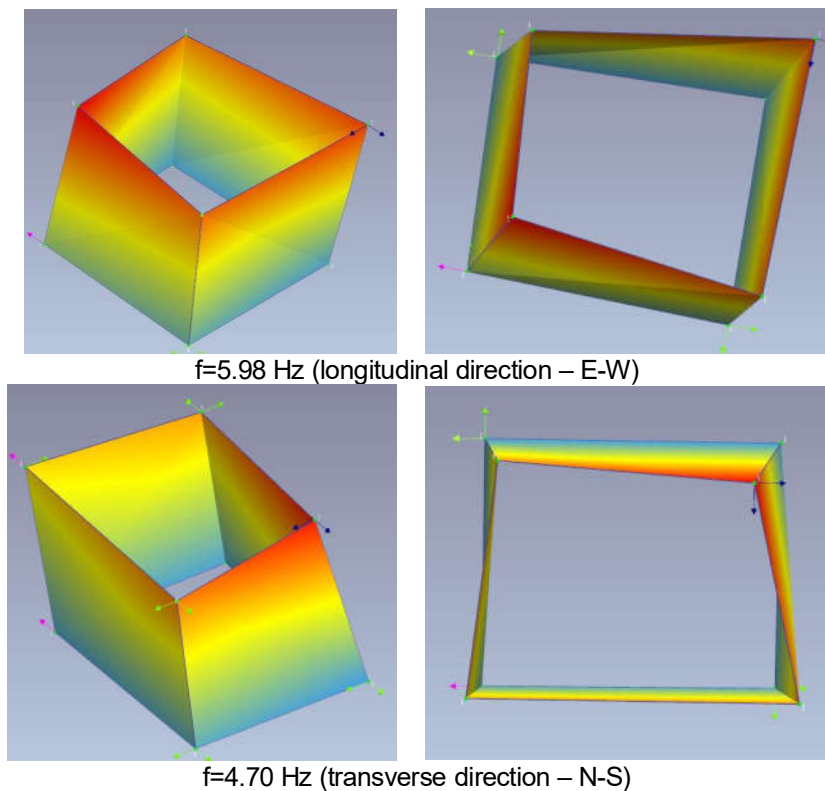
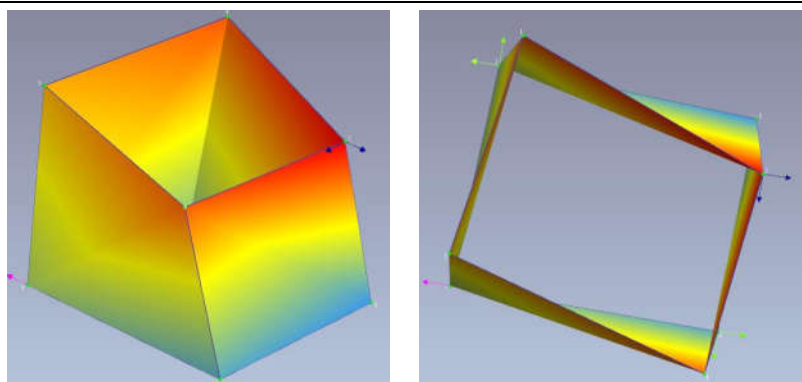
Figure 13. Natural frequencies and mode shapes [3]

These tests led to the identification of the natural frequencies  $f_{E-S} = 5.98$  Hz and  $f_{N-S} = 4.70$  Hz, corresponding to the natural periods  $T_{E-W} = 0.167$  sec and  $T_{N-S} = 0.212$  sec, in the two orthogonal directions, respectively. From the vibration modes, (fig. 13) it can be observed that the object, in its current state, vibrates as a single global unit. Displacements in both the longitudinal and transverse directions are generally translational, with minimal rotational movement in certain sections, more pronounced in the longitudinal direction, which is expected, given the imperfect symmetry of the plan (elongation of the altar area).

When compared with data from similar tests conducted in the 1990s ( $f_{E-W} = 6.00$  Hz and  $f_{N-S} = 4.80$  Hz) [6], which were measured using different equipment that required a longer testing time, it can be concluded that there have been no changes in the dynamic characteristics of the structure over the past 30 years.
