## INVESTIGATIVE WORKS TO DETERMINE THE NATURE OF CRACKS IN THE INTAKE TOWER OF THE ČELIJE DAM

**Key words:** Čelije Dam, Intake Tower, Cracks, Investigative Works, Technical Monitoring

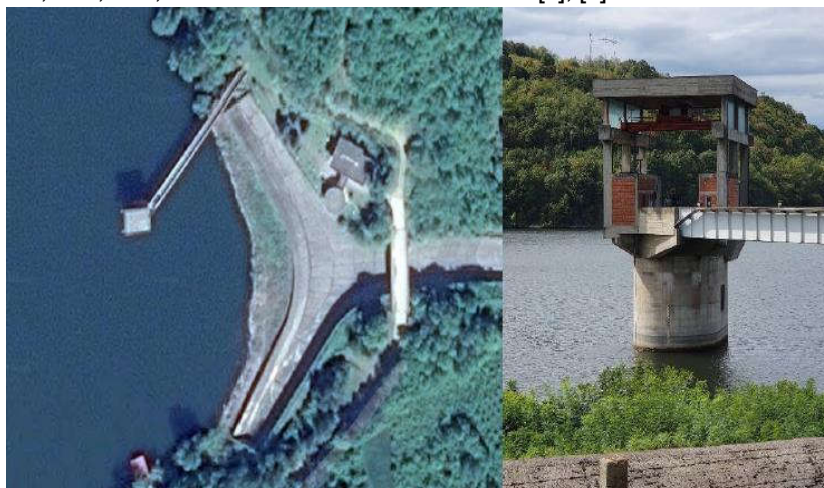
*Figure 1. Intake tower with access bridge*

A visual inspection of the intake tower, conducted following extreme hydrological events in the second half of 2019, revealed cracks along nearly the entire height of the structure. The cracks are grouped in three vertical directions, each oriented approximately  $120^\circ$  from the others. The crack openings are widest at mid-height, measuring between 1 and 2 millimeters.

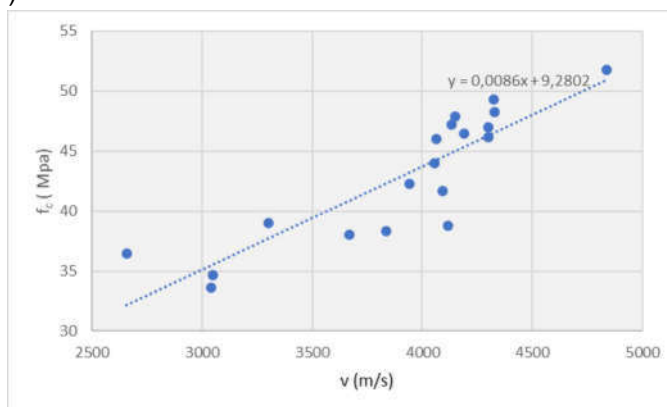
Figure 8. The relationship between the ultrasonic wave velocity and concrete strength

Considering the obtained results, it can be said that the concrete strength is in the range of 34.0 to 51.0 MPa, with an average of around 43.0 MPa.

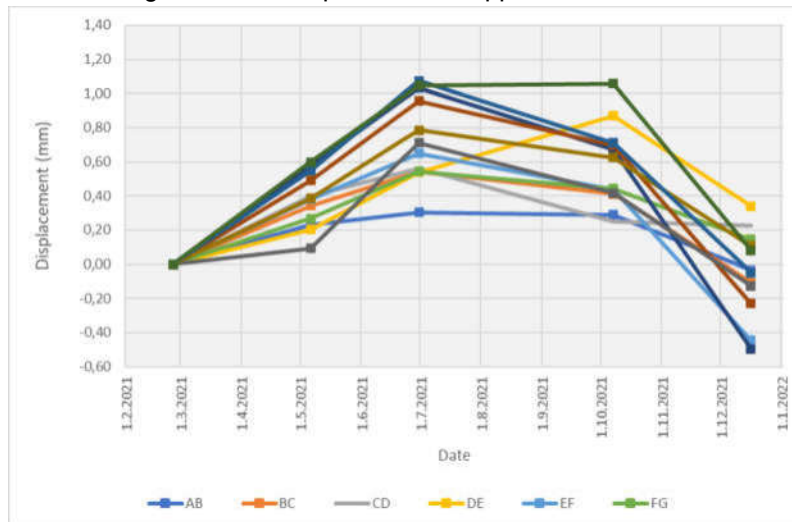
Figure 9. The change in the contour of the cylinder on one measurement profile (MP1)

The results of convergence measurements showed millimeter changes in the diameter of the intake tower and even larger changes in the circumference of the inner wall. These displacements are consistent with the external influences acting on the structure, primarily the changes in the water level in the reservoir and temperature changes. Namely, with the lowering of the water level in the reservoir, greater convergence was observed, which simultaneously coincided with an increase in both air and water temperatures. The increments of measurements on one of the profiles (MP1 at elevation 280.65 m.a.s.l.) are shown in the following image, where positive values represent the divergence of the reference points, and negative values represent their approach.

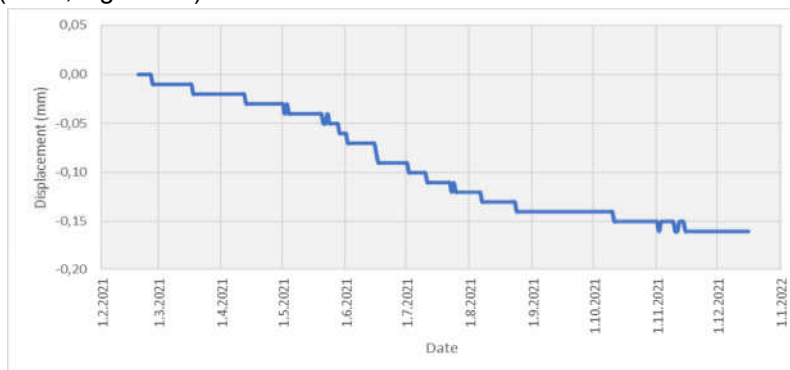
Figure 10. The diagram of crack behavior (deformeter D-4R)

The results of measuring the crack opening indicate cyclic deformations of the intake tower. The measured change in the opening is consistent with the results of the cylinder convergence measurements, meaning that the reduction in the crack opening coincides with the expansion of the tower's cylindrical contour. Positive values in the diagrams below refer to the upward movement of the right end of the crack relative to the left (D-4R, Figure 10.), the opening of the crack (D-4T, Figure 11.), and the lifting of the right end of the crack relative to the left (D-4V, Figure 12.).

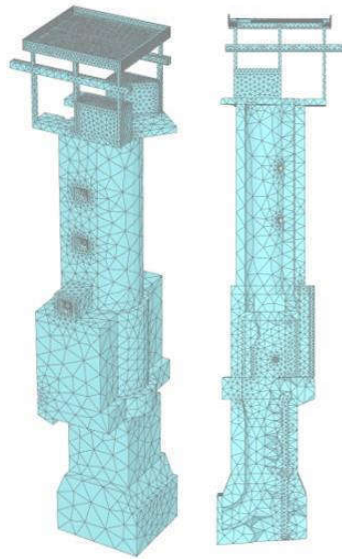
*Figure 13. FEM model of the water intake tower*

Considering that, according to the results of the investigative works, the cracks were caused by various deformations due to the complex actions acting on the tower, and taking into account the lack of the RC platform whose task was to tension the structure in multiple places along the height, the concept of the technical solution should be based on a solution that will bring the tower to the condition foreseen by the project.

It is recommended that the calculation analyses be performed using one of the FEM software packages that have the ability to model the complex geometry of the structure (Figure 13.), taking into account all combinations of actions acting on the structure, as well as boundary conditions. This type of modeling allows the designer, based on the presented measurements, to calibrate the parameters of the tower model and perform stress-strain analyses (for the case before and after rehabilitation) along with calculating the safety factor of the structure.

As an additional measure to tension the tower and ensure cooperation between the existing structure and the newly designed RC platforms, the technical solution needs to consider additional tensioning of the structure on the external side with RC pre-stressed beams at the levels of the new RC platforms or according to the results of the rehabilitation analyses. These works would be partly performed underwater, with the pre-stressing of beams being carried out after the construction of the RC platforms.
