Research paper

REHABILITATION OF THE TUNNEL KOSMAN DURING THE CONSTRUCTION OF THE SMOKOVAC - MATEŠEVO HIGHWAY SECTION IN MONTENEGRO

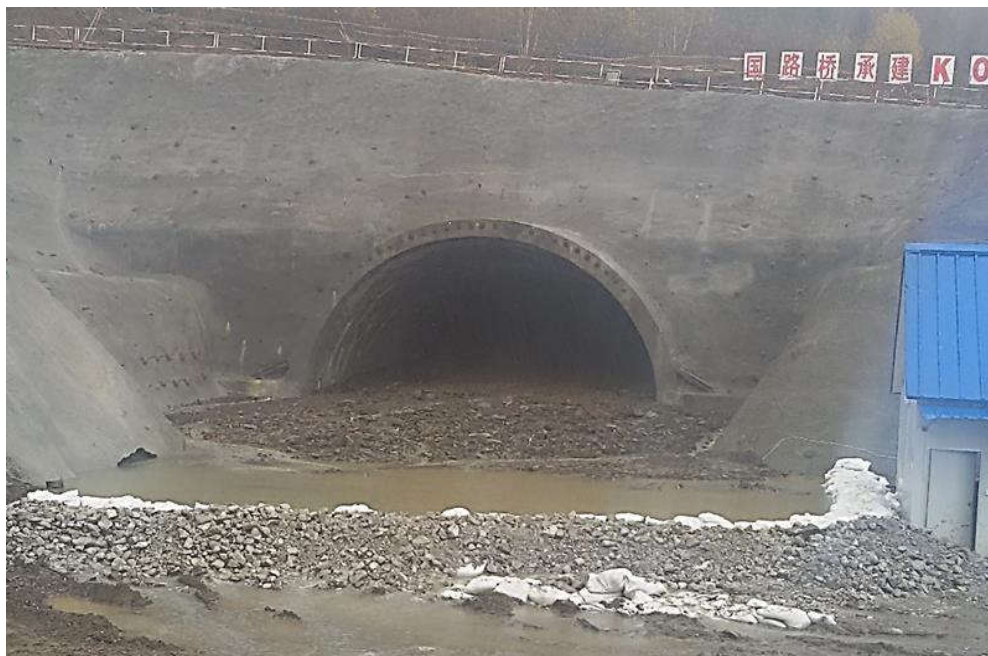
The contractor typically used a primary tunnel support of type Vpc to secure portal sections in quaternary sediments with low overburden. This type of primary support is used for the worst category of excavations, according to RMR classification (Rock Mass Rating - Bieniawski 1974). For the Kosman tunnel, the application of this type of primary tunnel support was planned for a length of 10 m from the exit portals. The initial collapse occurred 10 m from the tunnel portal in degraded and tectonically altered flysch sediments represented by siltstones, marls, and sandstones. The deformations rapidly progressed and in just a few hours they covered the tunnel's overburden, forming a channel 6-7m in diameter that reached the ground surface, Figure 1.

Figure 1. The soil that filled the right exit tube of the Kosman tunnel after the collapse of the excavation face

An analysis was conducted on the conditions that led to the collapse of the rock mass. It was concluded that the instability of the tunnel excavation was caused by an intensive inflow of groundwater. Under the pressure of the groundwater, the tunnel excavation collapsed, and since the layers of overburden of the rock mass were only a few meters, the surrounding ground also collapsed.

After the tunnel collapsed, water, soil, and stones flowed out of the tunnel portal for several days. The contractor immediately changed the main design of the Kosman tunnel. After conducting calculations, the contractor designed the primary tunnel support type Vpc-t. The rehabilitation of the Kosman tunnel began with the installation of fiberglass anchors with a diameter of Ø25 mm and a length of 9 m, which are installed with an overlap of 2 m. Then, drainage boreholes with a diameter of Ø50 mm and a length of 9m are placed at the face of the excavation. The contractor inspected the primary support of the tunnel that remained in place after the collapse and then geodetically determined its position. Then, to stabilize the slope, the contractor began to form a cut and cover section, in the right exit portal of the Kosman tunnel in a length of 10m as shown in Figure 3.

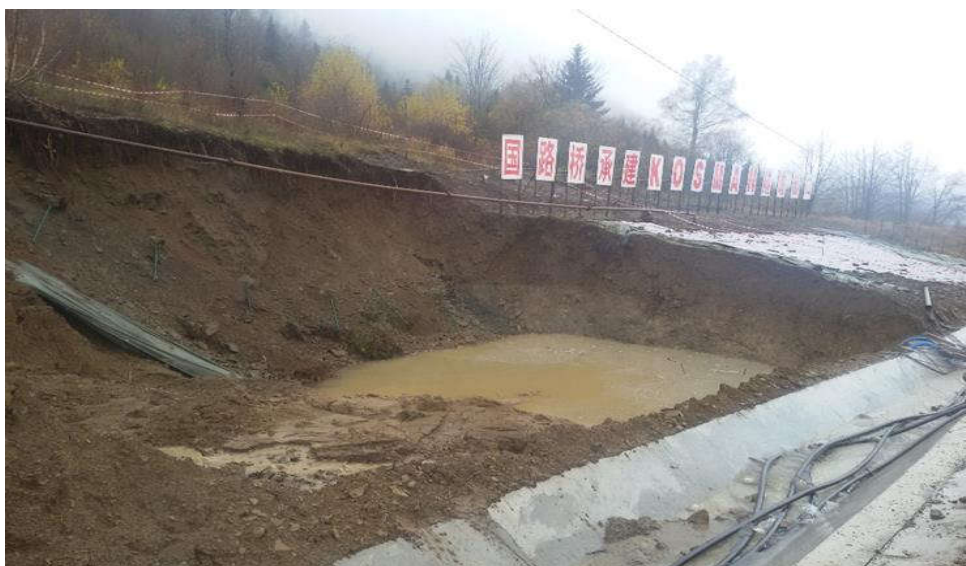
a few hours, the primary support began to deform, and the rock mass along the tunnel face began to collapse. Deformations increased rapidly and the next day the terrain above the right exit portal collapsed into the tunnel excavation, creating a wide channel on the surface of the terrain with a diameter of 6-7 m, Figure 2.

Figure 2. Area above the right exit portal of the collapsed Kosman tunnel

overburden was only 8 m high and the next morning, a wide channel with a diameter of 6-7 m was observed forming on the ground surface above the right exit portal.

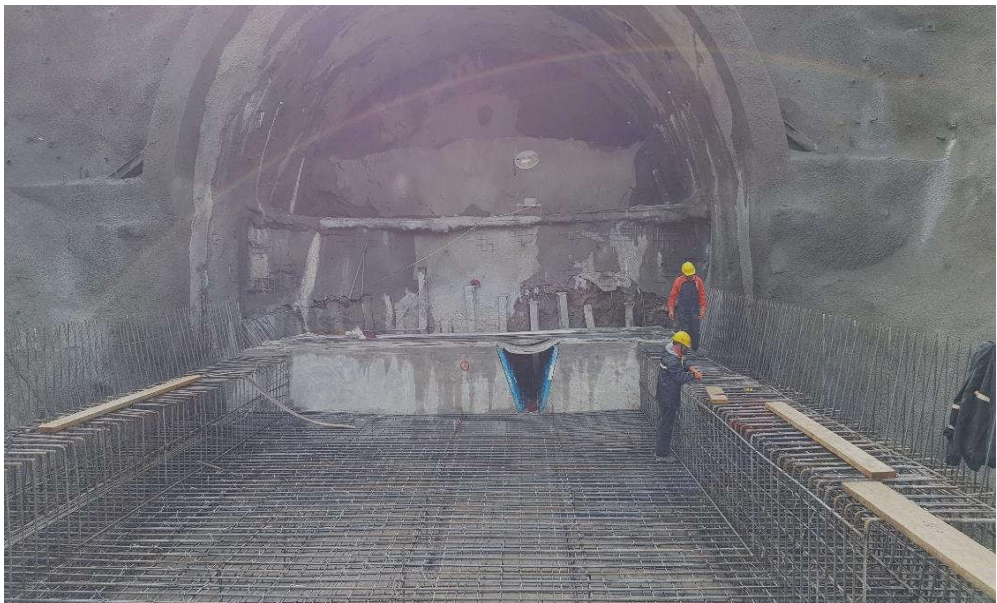
Figure 3. Formation of cut and cover section in the right exit portal of the Kosman tunnel in a length of 10m

When the secondary concrete lining in the tunnel portal area was completed, the phased excavation of the tunnel began, first the calotte, then the benches, with the sequential installation of a temporary invert.

Tunnel excavation was secured by installing of a primary support the Vpc-t type, which involves applying 26 cm of shotcrete, two layers of Q188 mesh reinforcement, the installation of SN anchors 6 m long in a grid of 150x60 cm, and the installation of steel arches type HE160A at a distance of 80 cm. Steel arches with extensions were formed at the contact between the tunnel calotte and the bench. The tunnel face was secured by installing a forepoling/piperroof, formed from IBO anchor bar with a diameter of 76 mm and a length of 9m. The piperoots are installed with a 2 m overlap and are formed at an angle of +5 ° to the horizontal plane. The main design allows deformation of the primary support up to 10 cm. The deformations were below this value, so the contractor installed a secondary lining of reinforced concrete with a thickness of 45 cm, thus completing the remediation works.
