Research paper

PROTECTION OF THE ARCHITECTURAL HERITAGE OF VLASOTINCE – NEMANJINA STREET

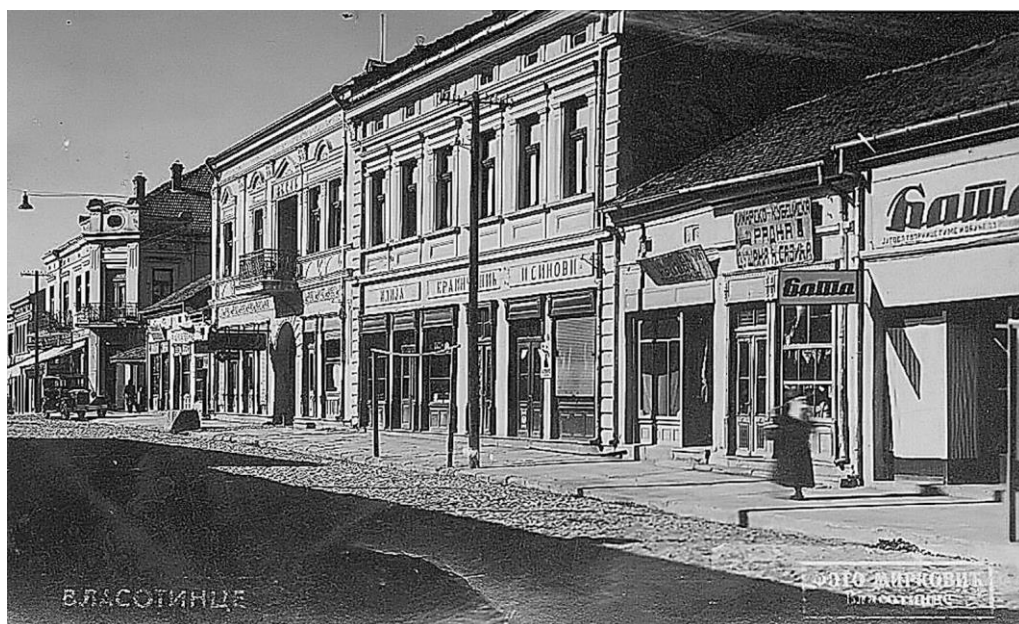
The **odd-numbered side** of Nemanjina Street today consists of a rather inharmonious sequence of buildings, due to uncoordinated building heights and diverse architectural styles resulting from different periods of construction. The sequence begins with two-story houses of fairly uniform appearance: the house of Sotir Valčić and the house of Vojislav Popović. This sequence is interrupted by the low, single-story shop of Blagoje Karuović. Next comes the two-story house of Krsta Bošković, one of the more prominent and valuable buildings in this section. After the intersection of Nemanjina Street with Gavriilo Princip Street, there is a three-story residential building whose height exceeds the ridge of the Bošković house, as well as that of the next, perhaps most representative building in the row—the house of Golub Arandelović.

Figure 2. Odd-numbered side of Nemanjina Street, documentation by ICHP Niš

The insertion of the taller residential building between these two significant structures diminishes the architectural value of the entire composition. Next is the house of Ilija Krainčanić, currently under reconstruction and lacking a roof structure. Upon completion, the building is expected to regain its original appearance and reestablish harmony with the Arandelović house.

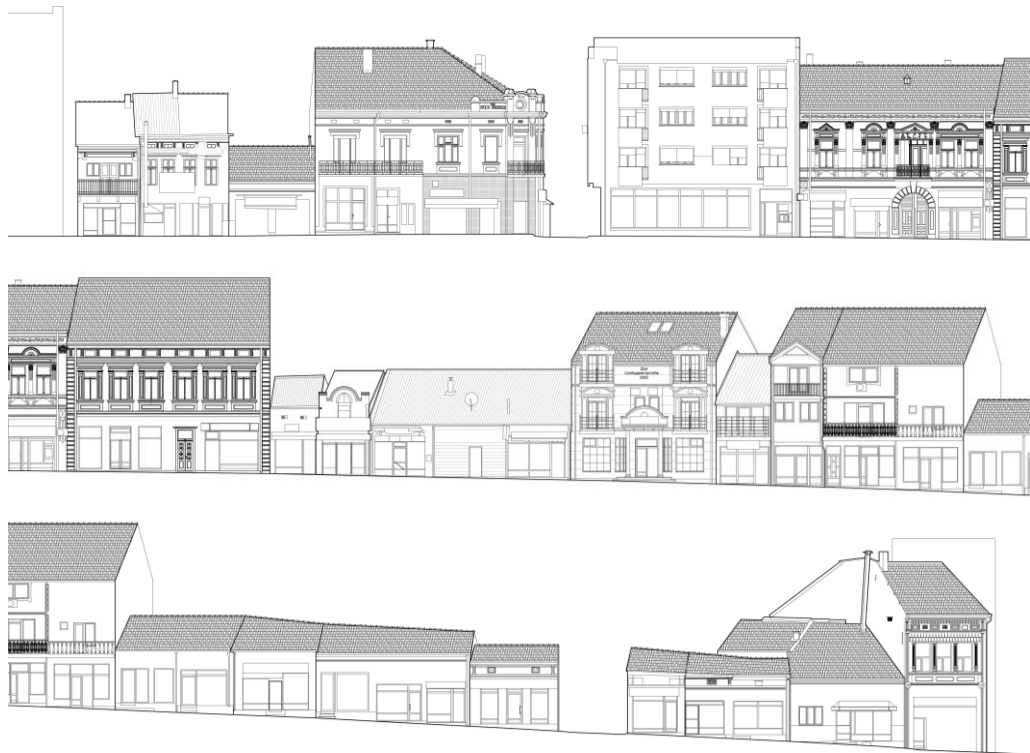
Figure 3. Odd-numbered side of Nemanjina Street, documentation by ICHP Niš

This is followed by a row of shops, along with more recent single-story structures forming a marginal block. However, these newer buildings differ significantly in scale, height, and façade treatment from the established context. The row is interrupted by Krnjino alley (Krnjino sokače), which once featured notable examples of Ottoman-Balkan architecture, and leads to the Spaska House (Spaskina kuća), which, along with the Giga House, represents an exceptionally valuable example of traditional Ottoman-Balkan residential architecture. The house was built around 1880 by Stavra Spaska Krainčanić, a merchant and the first president of the Vlasotince municipality after liberation from the Ottomans. Taking advantage of the terrain, the shops on the odd side of Nemanjina Street have large wine cellars accessed via Krnjino alley, while the storefronts are entered directly from Nemanjina Street. Although the architecture of these shops has been altered and adapted to Western European models over time, the façades facing Krnjino alley still bear the imprint of Ottoman-Balkan design. Unfortunately, this part of the ensemble has undergone drastic changes in recent years.

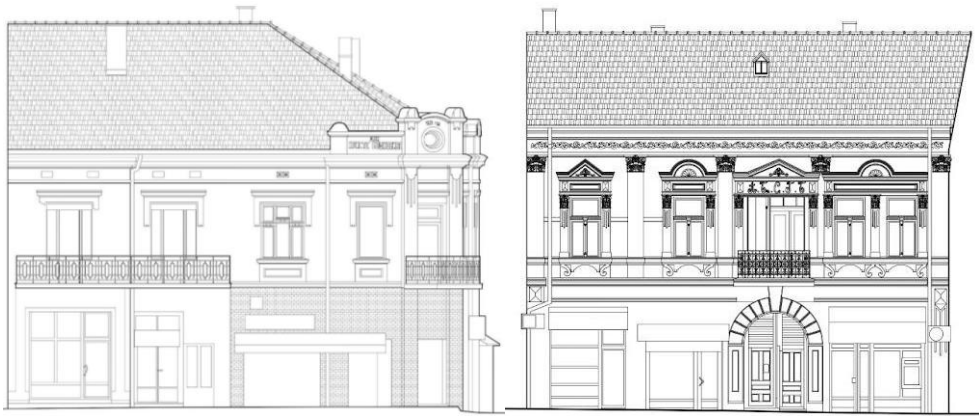
Among the notable buildings on the odd side is the house of Krsta Bošković, built in 1925. It is a one-story corner building featuring classical architectural elements associated with

newer trends in architecture. The ground floor is characterized by exceptionally tall storefronts and pronounced pilasters with vertical fluting that continue to the upper floor and flank the corner section of the building. The corner is further emphasized by flat attic walls with inscriptions reading “House of Krsta Bošković” (Dom Krste Boškovića), as well as a semicircular pediment above the corner façade bearing the year of construction.

Figure 4. Façades of the Bošković and Arandžević houses, drawings from ICHP Niš documentation

The house of Golub Arandžević Belja is a one-story structure with a richly decorated façade. It features neo-Renaissance elements on the upper floor and classical details on the ground floor. With its dominant rusticated segmental archway at ground level, an iron-wrought balcony above, and an upper floor richly ornamented with stucco decoration, this house stands as the most striking feature of the street.

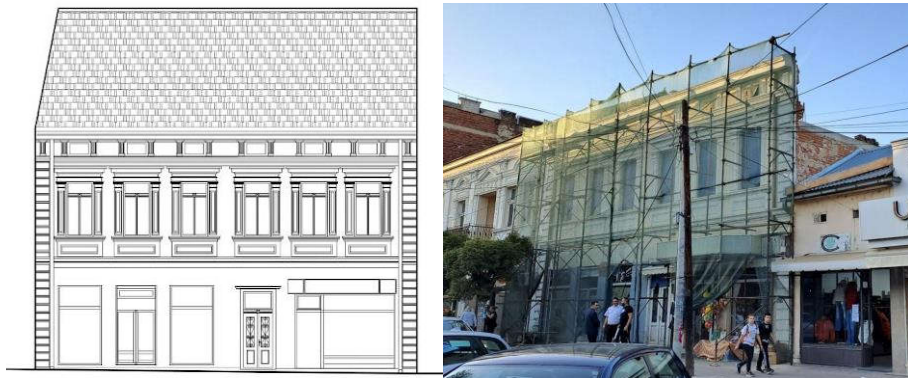
Figure 5. Ilija Krainčanić House, drawing and photo from ICHP Niš documentation

The house of Ilija Krainčanić is a tangible witness to the urban development of the old bazaar. Built in 1907 in the spirit of neoclassicism and academicism, it features distinct window decorations, prominent architraves above the openings, and articulated string and cornice moldings [4]. The structure is largely preserved in its original form.

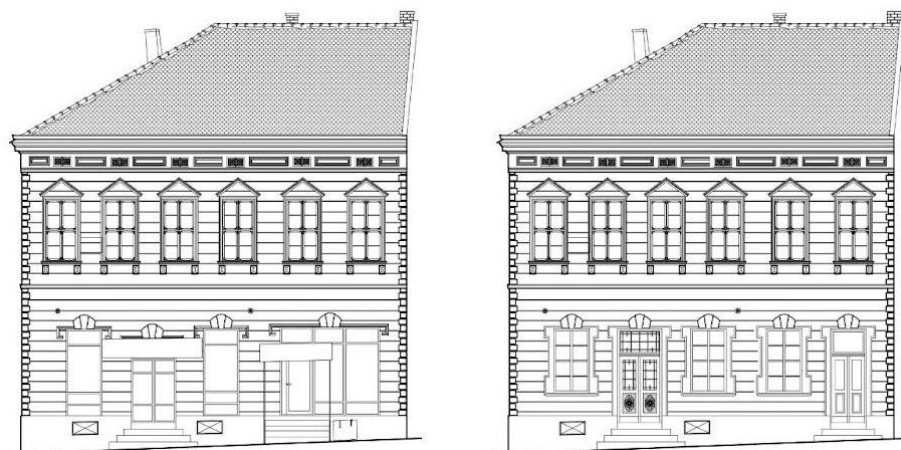
One of the most representative buildings on this side of the street is the house of Đorđe Popović Krčimirac, with a basement, ground floor, and one upper floor. The ground floor is designed in the academicist style, featuring horizontal fluting and emphasized corners. The upper floor is adorned with rhythmically placed windows topped with triangular pediments and framed by narrow, fluted pilasters.

Figure 7. House of Đorđe Popović Krčimirac, current and original condition, documentation by ICHP Niš

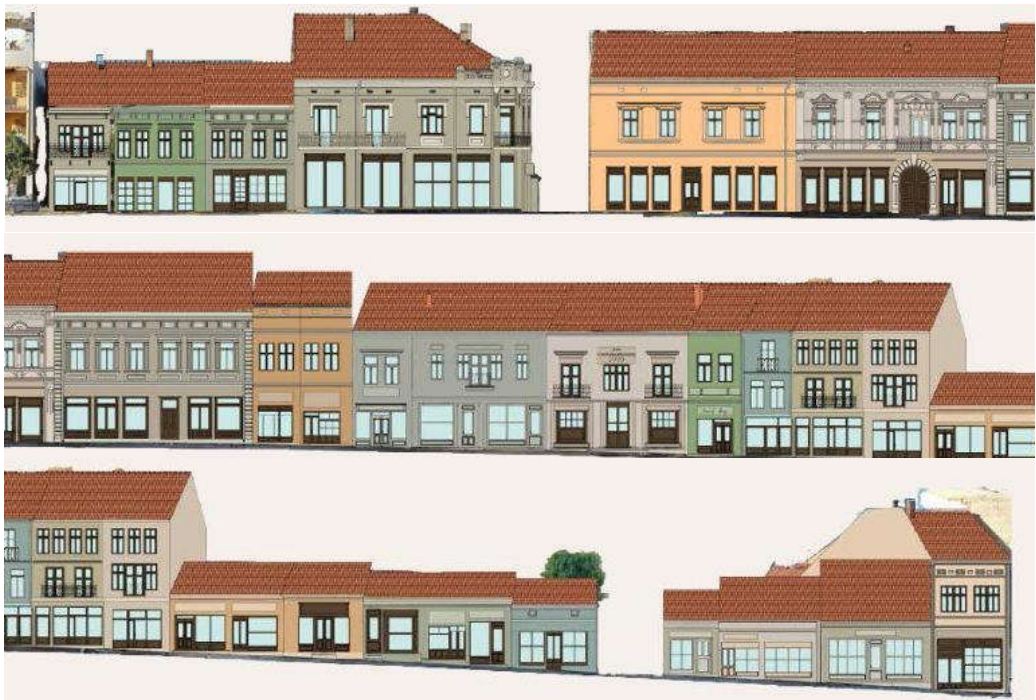
Figure 8. Odd-numbered side of Nemanjina Street, proposal for improvement by Ilija Ilić, Teodora Dragojević, and Maša Milošević

With the aim of deepening the understanding of potential development directions for this part of Vlasotince čaršija, a student architectural workshop titled "Preservation of Architectural Heritage: The Old Čaršija of Vlasotince" was conceived and implemented [9]. The workshop was organized with the aim of exploring ways to integrate the topic of cultural heritage protection and preservation into the master's study program at the Faculty of Civil Engineering and Architecture, University of Niš. As the field of heritage preservation in Serbia faces challenges due to a lack of specialized personnel, it is essential to involve the academic community in decision-making processes and in planning the future development of small towns [10]. Its goal was to introduce architecture students to the fundamental principles of conservation practice and the heritage values of Vlasotince, as well as to place them in the role of designers working within a protected urban ensemble.

Students received drawings of the current condition of the street fronts, a detailed assessment of the present state, and analyses of inappropriate interventions that have degraded the value of buildings and ensembles. They also received design guidelines developed by the Institute for Cultural Heritage Preservation, which served as a basis for further project development [9].

Through the proposed student solutions—based on prior analyses and consideration of the broader context rather than fragmentary designs for individual buildings—the potential for improving the condition of the area in question becomes evident.
