## INVESTIGATIVE WORKS TO DETERMINE THE NATURE OF CRACKS IN THE INTAKE TOWER OF THE ČELIJE DAM

**Key words:** Čelije Dam, Intake Tower, Cracks, Investigative Works, Technical Monitoring

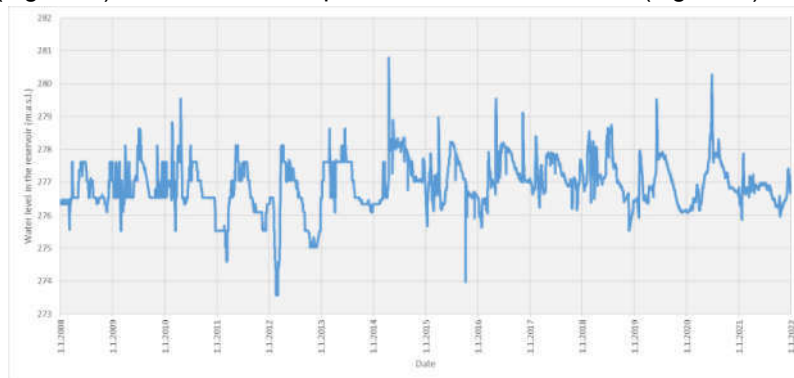
Figure 2. Water Level in the Čelije Reservoir

Considering that there is a technical monitoring system in place at the dam, for the purpose of analyzing the condition of the structure, all available measurement and observation data from the tower were collected. This includes data on the water level in the reservoir (Figure 2.) and the water temperature at the intake levels (Figure 3.).

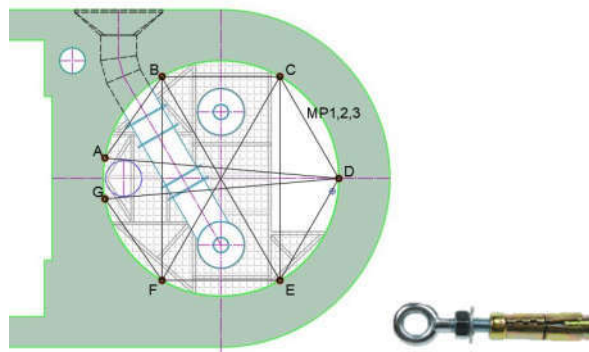
*Figure 5. Measurement profile and benchmark for convergence monitoring*

The benchmarks for convergence monitoring were embedded in the concrete of the intake tower's inner wall, with a total of 7 benchmarks installed on each of the 3 measurement profiles (at elevations 280.65, 274.80, and 268.60 meters above sea level). The distances between pairs of benchmarks are measured, and by subtracting the results from the previous measurement series, relative changes in distance are obtained (Figure 5.). These values are used to monitor the behavior of the tower profile over time. A total of 12 measurement directions were established for each profile.

The results of convergence measurements showed millimeter changes in the diameter of the intake tower and even larger changes in the circumference of the inner wall. These displacements are consistent with the external influences acting on the structure, primarily the changes in the water level in the reservoir and temperature changes. Namely, with the lowering of the water level in the reservoir, greater convergence was observed, which simultaneously coincided with an increase in both air and water temperatures. The increments of measurements on one of the profiles (MP1 at elevation 280.65 m.a.s.l.) are shown in the following image, where positive values represent the divergence of the reference points, and negative values represent their approach.

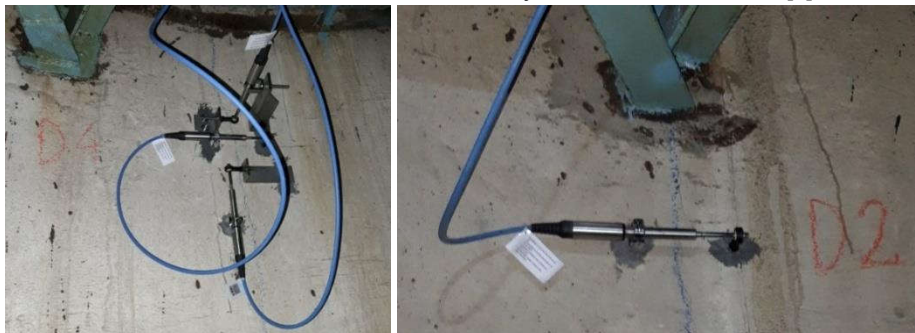
*Figure 6. Installed Teledeformeters (Triaxial and Uniaxial)*

The opening and closing of cracks on the inner wall of the intake tower of the "Ćelije" dam was monitored using electrical crack gauges (teledeformeters, Figure 6.). A total of 9 teledeformeters were installed on the structure, including 6 uniaxial and 3 triaxial devices.

In uniaxial teledeformeters, measurements are taken in the principal direction of crack activity, i.e., perpendicular to the direction of the crack. A triaxial teledeformometer is essentially a set of three uniaxial sensors installed and measured along three orthogonal directions: direction "T" (crack opening/closing), direction "R" (displacement along the crack line), and direction "V" (displacement perpendicular to the inner wall plane of the tower).
